# The Restoration of Thorpe Watermill, Bothwell, Tasmania

JOHN BIGNELL

*Thorpe Watermill is the only known Australian example of a traditional water-driven flour mill, that can be operated in the original manner.<sup>1</sup> This uniqueness results from restoration work that was undertaken during the 1970s by the Bignell family, who own the mill. The work was carried out particularly by John and Peter Bignell, with very few resources. In February 1988 the editor of this Journal visited the mill and persuaded John Bignell to write this account of how the work was done. Professional conservationists may debate some of the methodology but the achievements of this private restoration project deserve both respect and gratitude.*

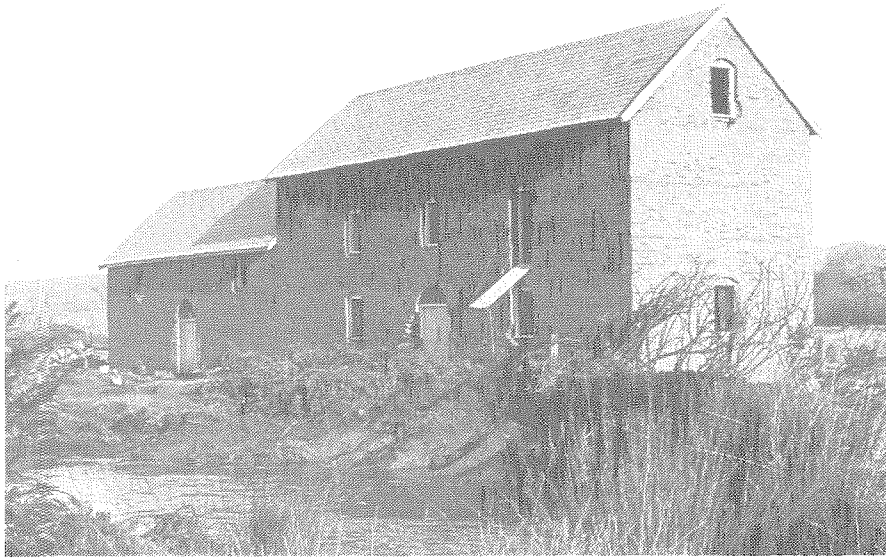
Fig. 2: Thorpe Watermill during restoration in 1975. This view is of the eastern side of the building and shows the redug head-race and the new roof. Photograph by Peter Bignell.

Apart from machinery hire to repair waterworks, the re-roofing was the major cost in restoring the mill and was the only time we employed professional help. All subsequent work was carried out by members of the family and by any unfortunate visitor who happened to come along during digging or rock-breaking jobs. However, the majority of the work was done by my brother Peter and myself. Once we became obsessed with finishing the task, we devoted to the mill almost every weekend and spare minute from farm work for about three years (Fig. 2).

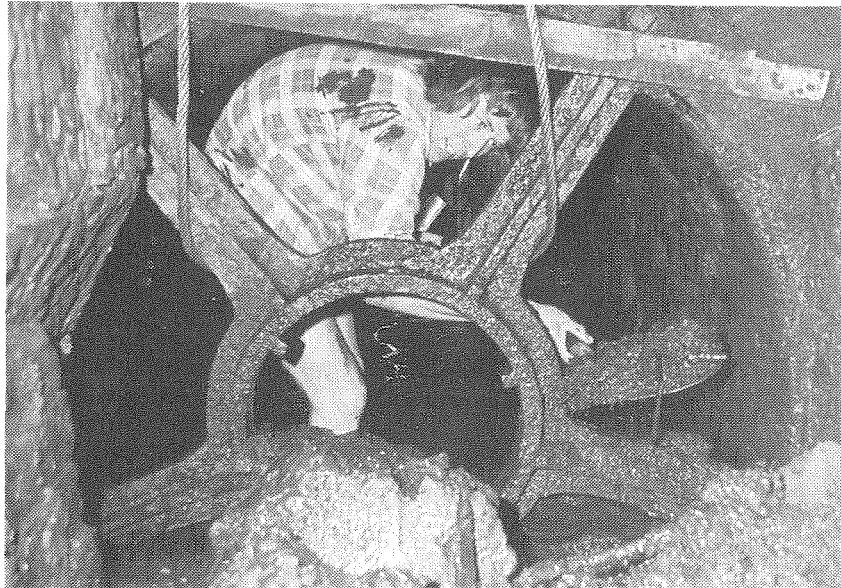
*Fig. 4: John Bignell shovelling mud from inside the waterwheel in 1975. Prior to reconstruction, the wheel had become buried in silt and was covered by water. Photograph by Peter Bignell.*
